Engineering geology characteristics of Miyanrood dam site (South East of Iran)

Abstract: Nutritional Miyanrood earth dam with a concrete spillway span length of 80 meters, along the crest of the dam, 413 meters, the height of the basement, 14 m and height of the river, 10 meters, in the southeast Mirjaveh, Sistan and Baluchestan is located. The dam, with the objectives, control, storage and flood guidance for artificial recharge of aquifers is built. In this research, library research, including gathering information from books, these and similar letters, aerial photographs and satellite images and reports from the District of Sistan and Baluchestan, then, field visits, Geology and engineering geology survey of the reservoir and dam axis. Dam site, on the set of the Cretaceous-Eocene flysch, a part of the Neogene clastic rocks are volcanic and ultrabasic and products. 233 joints of the abutments were harvested. The bedding, the right abutment and varied between 60 and 85 degrees slope, between 145 to 335 degrees. The joint sets available, perpendicular to the layering process, which will certainly cause the water to escape. Anchor the barrier layer Miyanrood, as close to vertical

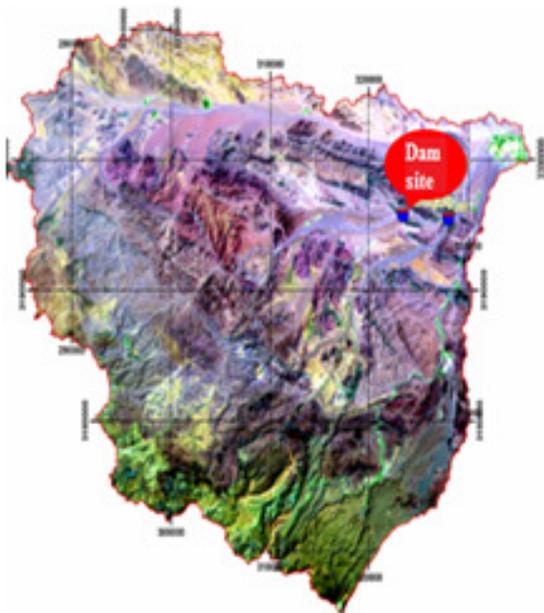
Fig.2: Satellite image of the catchment Ladiz - and at the site

Quaternary resulted are the formation of various alluvial deposits (Fig2, 3).

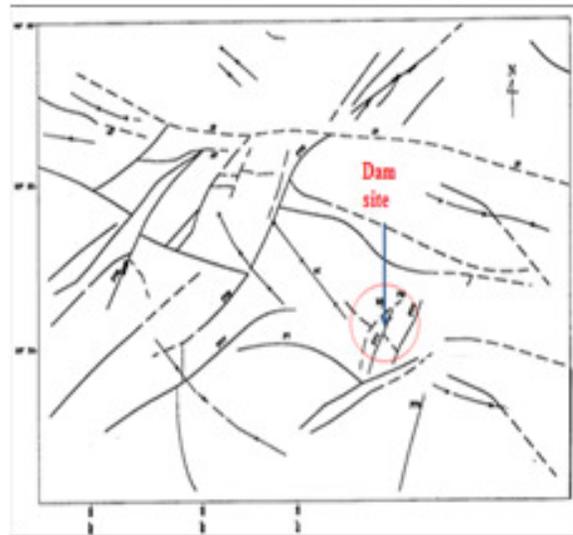
Fig.3: Faults closely the Miyanrood dam site

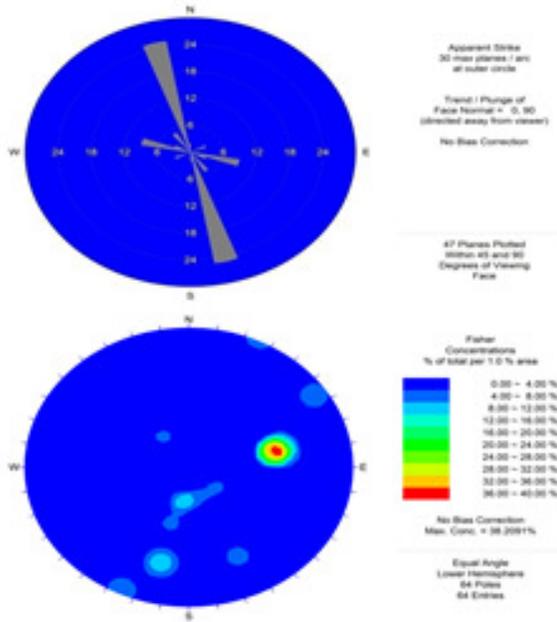
Fig4: The figure rose diagram and joint pole curve equivalence on the right abutment

A total of 64 discontinuities in the right Tkyh-Gah harvest. Surface discontinuities harvested, rough, without filling, an average of 1 to 2 mm distance between the joints and in some cases, such as the location of folds and faults more than 2 centimeters. The backrest joint sets that include a total of 2 layers and lots of tangled fractures have been identified. Charts and graphs of polar curve equivalence rose joints 3 and 4 are shown in the Fig4.

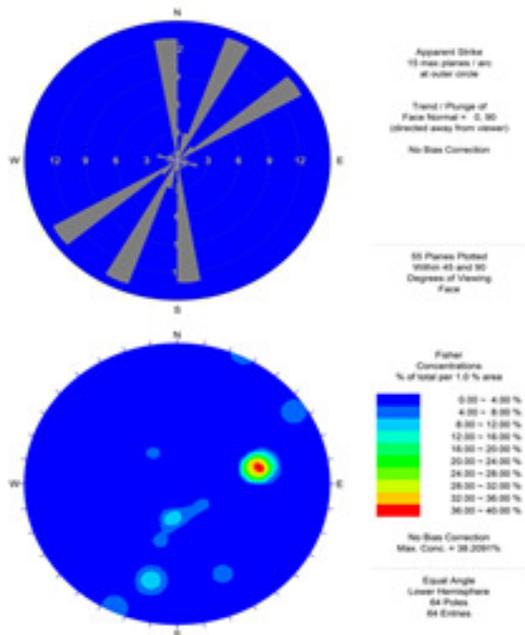
Fig.5: The figure rose diagram and joint pole curve equivalence on the left abutment

The left abutment, a total of 64 surface discontinuities is harvested. A total of 3 sets of joint specified. Equivalence polar curve charts and graphs rose joints are shown in Fig5.
